## Errata 1.0 Problems with configuration of FPGA's ABCDE

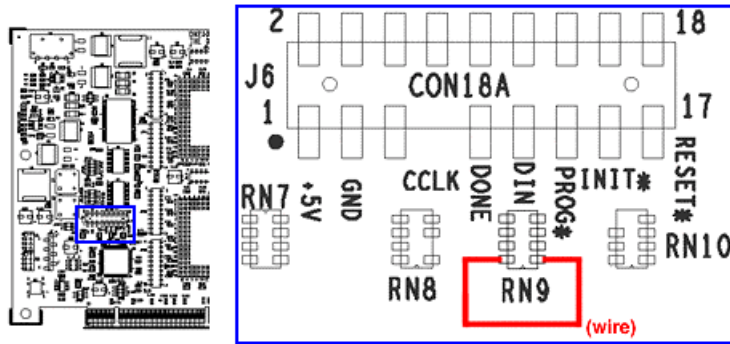
Some initial PWB's were shipped with a series termination resistor on CCLK that was too large for the load. This caused a transmission related hump in the rising edge of this clock and caused problems with the configuration mechanism on five of the Xilinx parts.

1. Replace resistor network RN9 with a 10 ohm value.
2. Solder a wire across pins 1 and 8. (See diagram)
