DN8000k10PCIE8 Errata

Last update: April 19, 2007

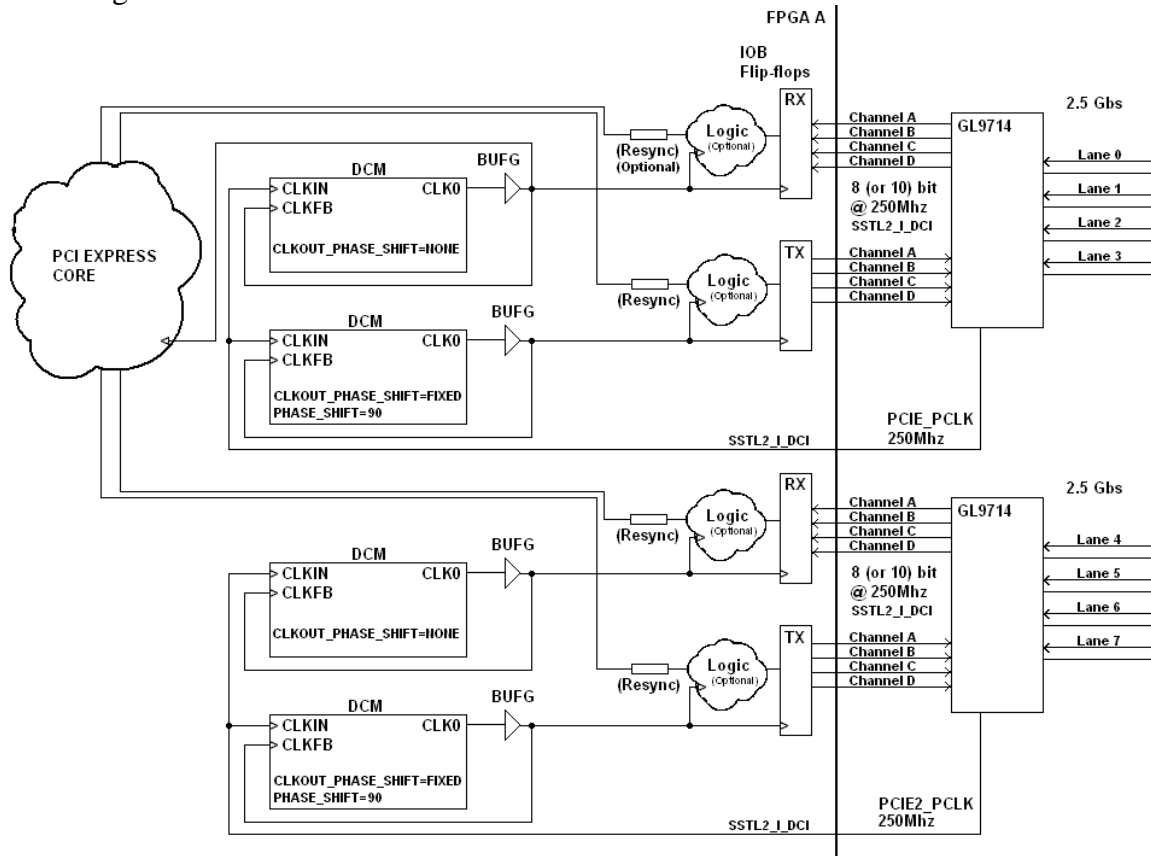
PCIE2_PCLK is not connected to a global clock input pin. The signal PCIE2_PCLK, intended for synchronizing the interface between FPGA A and the second Genesys Logic 9417 (U6), is not connected to a Virtex-4 "GC" global clock input pin. As a result, it cannot be used reliably as a clock signal in the FPGA design.

PCI express 8-lane operation cannot be used.

Previous suggestions for correcting this problem included using the signal PCIE_PCLK signal for synchronously communicating with both GL9714 devices. This method has been shown to be unreliable, because the phase relationship between PCIE_PCLK and PCIE2_PCLK can change when the GL9714 goes into power-down mode.

The current work-around requires a rework wire to be added to your board to connect the PCIE2_PCLK signal to a "GC" pin on the Virtex-4 device. The Dini Group will

implement this rework on your board at your request.
 After the rework, the signal PCIE2_PCLK will connect to
 FPGA pin AP22 (and not AW15).

**Since AP22 connects to the Header A signal HAP75, this signal should not be used
 on the header.**

When using the work-around or a rebuilt board, the validated clocking scheme is shown
 in the diagram below. The new clocking scheme is also described in the latest version of
 the user guide.
